Water Resources Department

January 26, 2017

Re: Barnes Butte Dam (B-38) – Inspection Summary

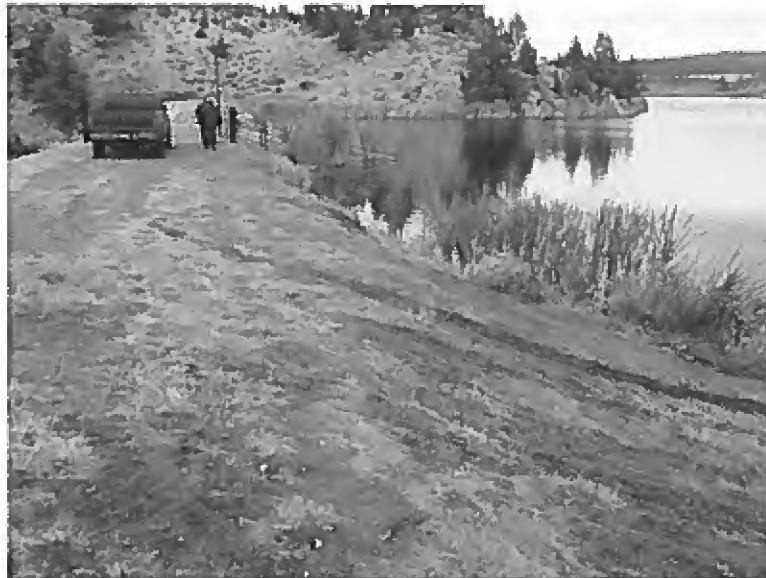
Minimum freeboard as measured in the last inspection was between 3.3 and 3.5 feet, which is insufficient. The crest has decreased over time, with low spots, due to settlement of the dam, cattle trampling, and possibly vehicle use. The now reduced height of the dam also reduces the freeboard (distance between the water level and the top of the dam). This increases the risk of overtopping during significant storm events, and reduces the capacity of the emergency spillway to pass flood flows during significant storm events, since water depth in the spillway is reduced by the amount of freeboard loss.

1. Inspect the dam if there is an intense rainstorm at the site, especially if this occurs when there is snow on the ground. Utilize the EAP to determine if further action is needed. **This could happen in the next few months.**
2. Replace lost fill on the crest of the dam. By our approximate calculations this is up to two feet of depth at the lowest spots on the crest. This should occur during relatively dry periods when equipment can easily operate on the dam.

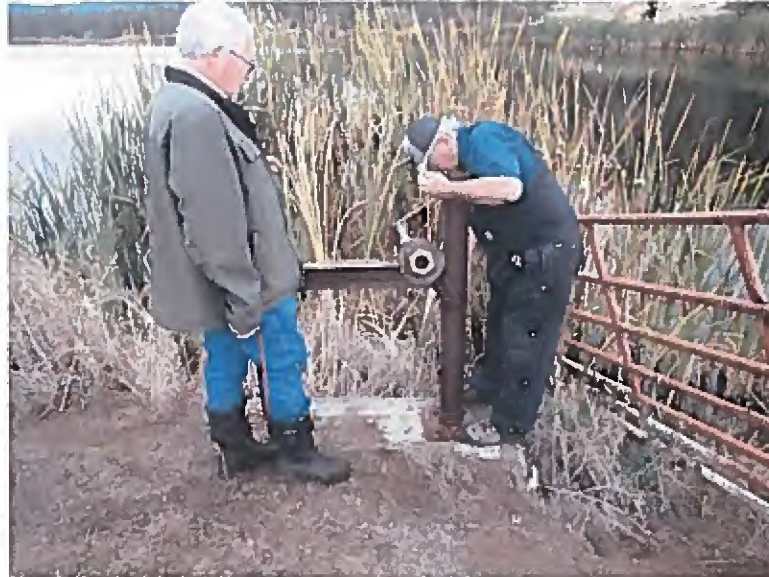
Operation of valve

The valve was operated for the first time since some time prior to my 2011 inspection. An operational valve is essential for maintenance of the dam. It is also necessary in an emergency, where the reservoir needs to be lowered quickly. It is now important to cycle this valve on an annual basis. Cycling means completely opening the valve and then closing it. Valves that are not cycled will eventually stick and become inoperable. A working low-level conduit, which relies on this valve, is critical to the safety of this dam.

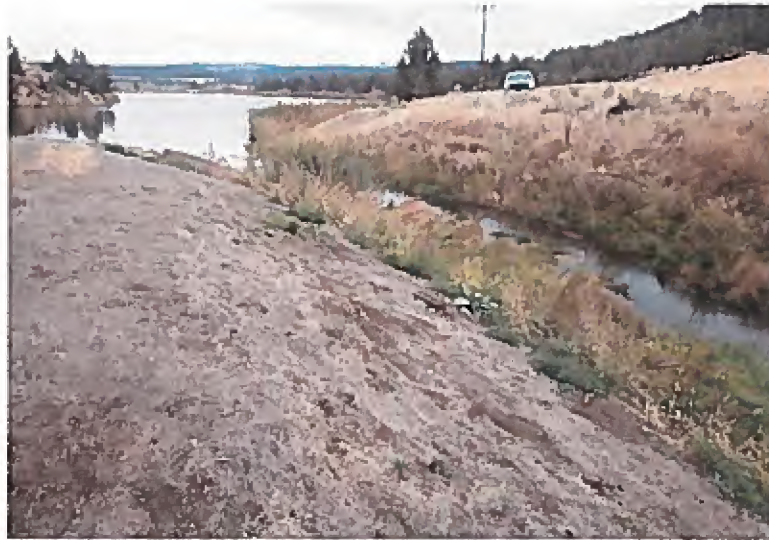
Spillway approach and control section

During our inspection, we took rough measurements of the spillway and dam crest in order to approximate the reduction in spillway capacity due to the low spots on the crest. The calculations indicate that the spillway capacity has been reduced by more than 20% from the designed condition. It should be noted that the calculations were based off of rough field measurements and as such represent an approximation of the reduced spillway capacity. Although we are certain that there is a reduction in spillway capacity because of the low spots on the crest, the actual magnitude of the reduction can only be determined through a detailed survey of the dam crest and an engineering analysis.

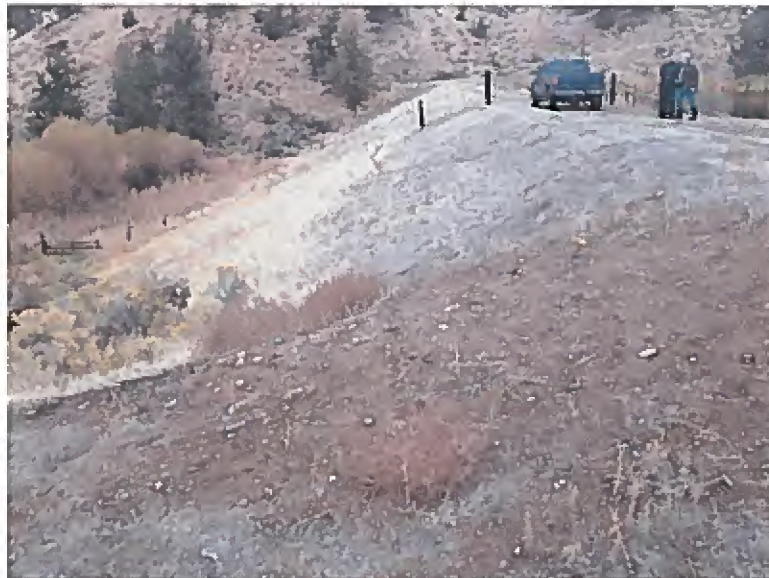
As previously stated, this embankment has become lower over time through a combination of settlement, trampling, and vehicle traffic. Other than having a lower crest and reduced flood capacity, there is no other evidence of problems with the embankment.

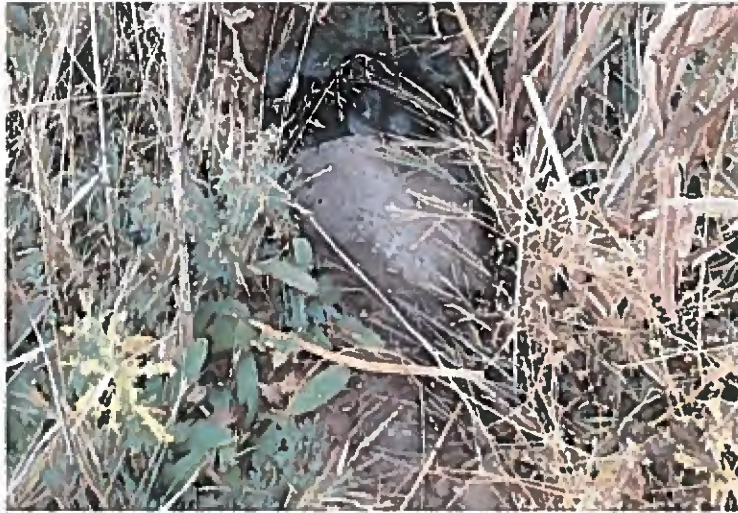
Outlet of low-level conduit

We observed increased flow through this conduit as the valve was opened, so it appears to function correctly. The steep pipe appears to be in reasonable condition. The area around the conduit, and the overall toe of the dam, are covered with brush, so seepage flows could not be evaluated.
